**ALABAMA HAZARDOUS WASTES MANAGEMENT AND MINIMIZATION ACT
(AHWMMA)**

Compliance Evaluation Inspection (CEI) Report

Hyundai Power Transformers USA, Inc.
215 Folmar Parkway
Montgomery, Montgomery County, Alabama 36105

March 24, 2016

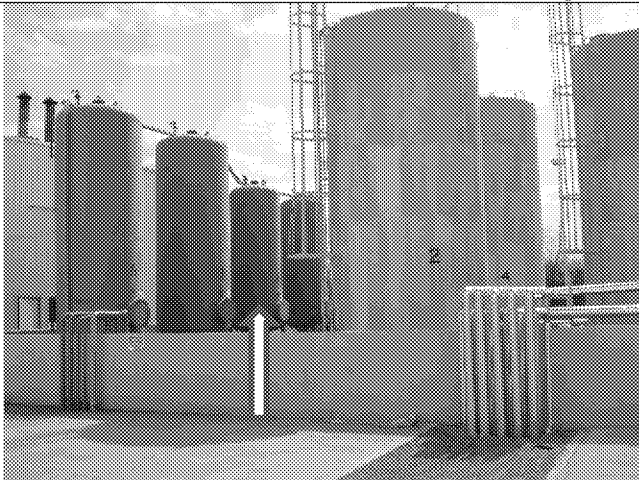
The oil used during the transformer testing phase can be reused multiple times, but it eventually breaks down and is no longer suitable for use. At that point, it is pumped into Tank #8, which has 2,600-gallon

capacity. The used oil is stored until it is collected by either Safety Kleen (EPA ID Number TXR000081205), which is based in Richardson (Dallas County), Texas or Buck Oil (EPA ID Number ALR000009571) in Montgomery, Alabama. See Photograph #2.

2. Used oil tank (#8) – not marked

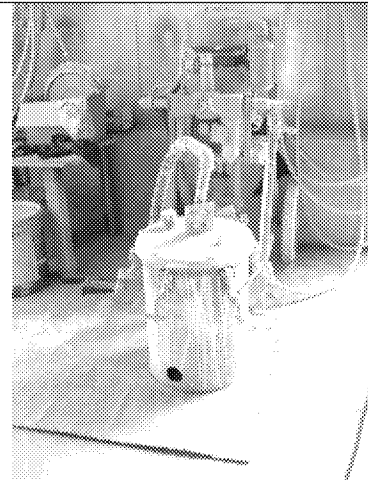
In this area, any portions of the transformer that will be exposed to the elements are coated to control corrosion. Most of the painting is done using a compressed air sprayer inside a paint booth; the paint pot is equipped with a removable liner. Once empty, the liner with the remaining paint (called a "puck") is placed in a solvent distillation unit. Recovered solvents are used to clean the paint guns. The bottoms from the distillation unit are managed as a hazardous waste; the empty liners as well as the paint filters are managed as solid waste. Aerosol spray paint is used to touch up small areas. According to the fabrication manager, spent aerosol cans are punctured, but no effort is made to capture or contain the liquid or propellants.

3. Paint Pot

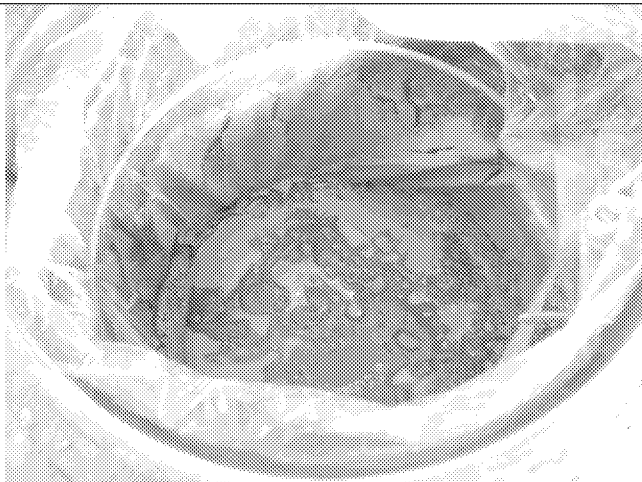
4. Paint pot liner

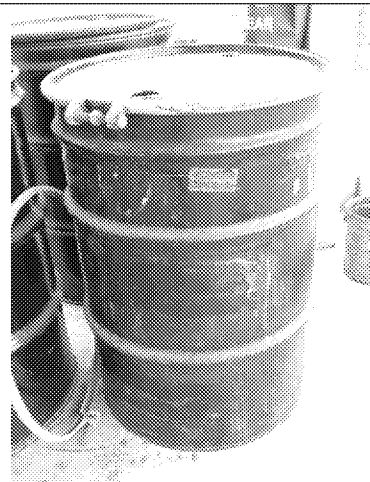
One 55-gallon open-top satellite accumulation container containing paint pucks was not marked in any way. In addition, its lid was in place but was not secured by a drum ring. This container was closed properly prior to our departure from the site. Two non-empty aerosol paint cans were discovered in the solid waste trash. See Photograph #3 through Photograph #6.

5. SAA drum of paint pucks – not marked or closed

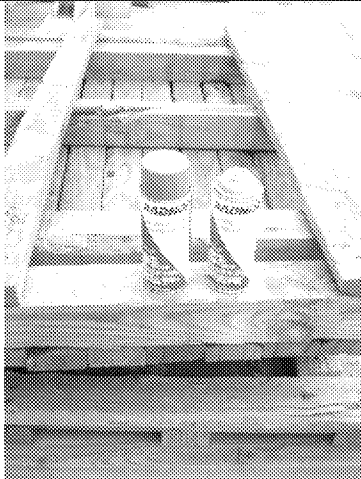
6. Non-empty aerosol cans retrieved from trash

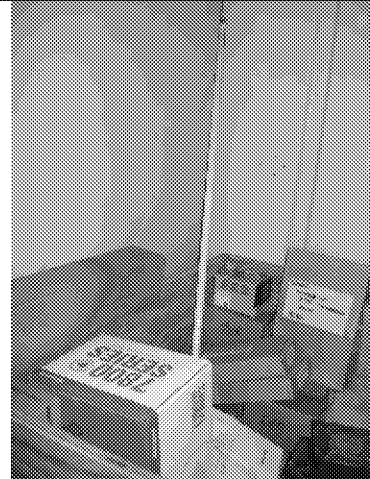
At the time of the inspection, there was one uncontained, unmarked two-foot long fluorescent lamp was found in the area designated for UW and electronic waste storage. The waste lamp was immediately placed in a marked and dated corrugated cardboard box.

7. Uncontained UW lamp

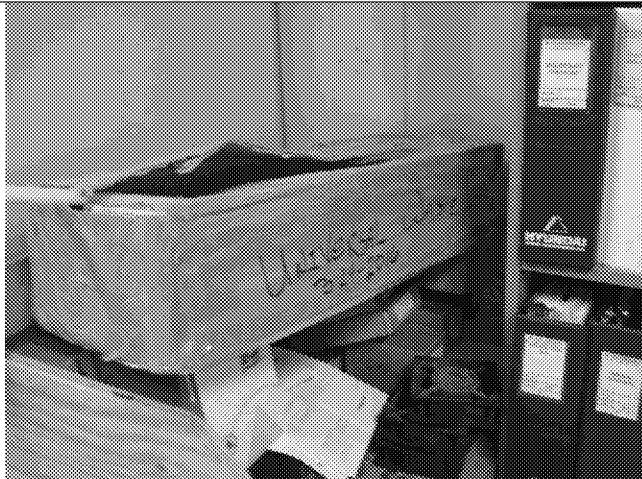
8. UW lamp placed in a marked, dated box

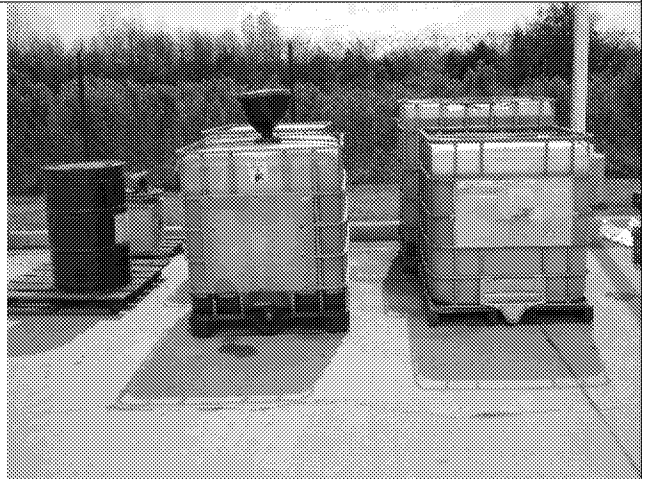
Behind the Maintenance Shop, there were four totes of used oil staged on the concrete driveway. None was marked with the words "Used Oil". One of the totes had a lidded pouring funnel screwed into the bung, but there was no latching mechanism on the funnel. Consequently, this tote was open.

9. Used oil totes – not marked, one not closed
